EGYPTIAN CIVIL AVIATION AUTHORITY

REPORT OF INVESTIGATION OF ACCIDENT

EgyptAir Flight 990

Boeing 767-300ER SU-GAP

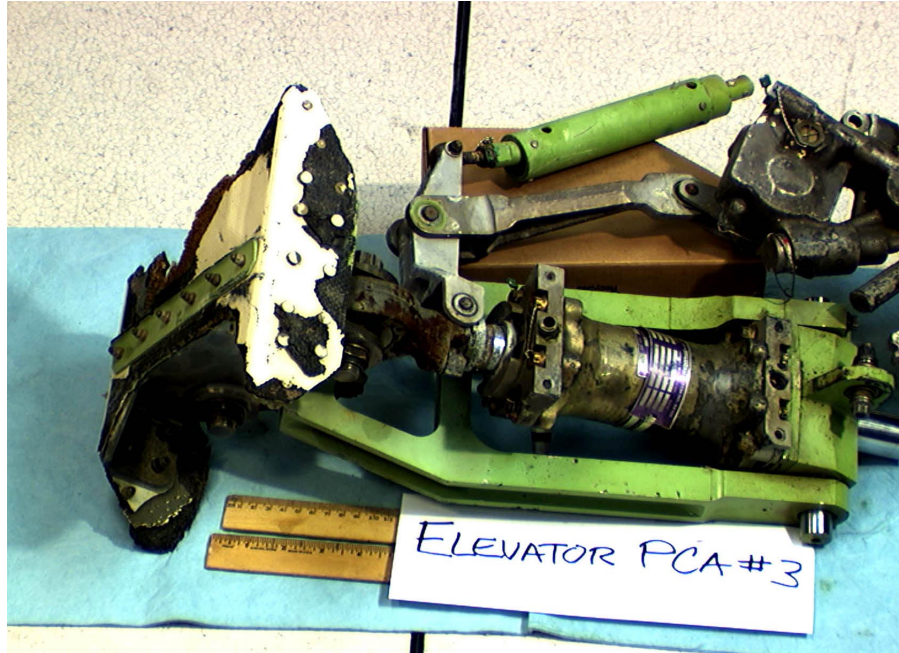
- b. The piston extension was 0.28 inches between the snubbing gland and the runout area of the piston rod end (the PCA was almost fully retracted).
- c. The four bolts that connect the manifold to the PCA were sheared, but the manifold was still connected to the piston through the summing lever.

Figure 17: Recovered PCA # 3

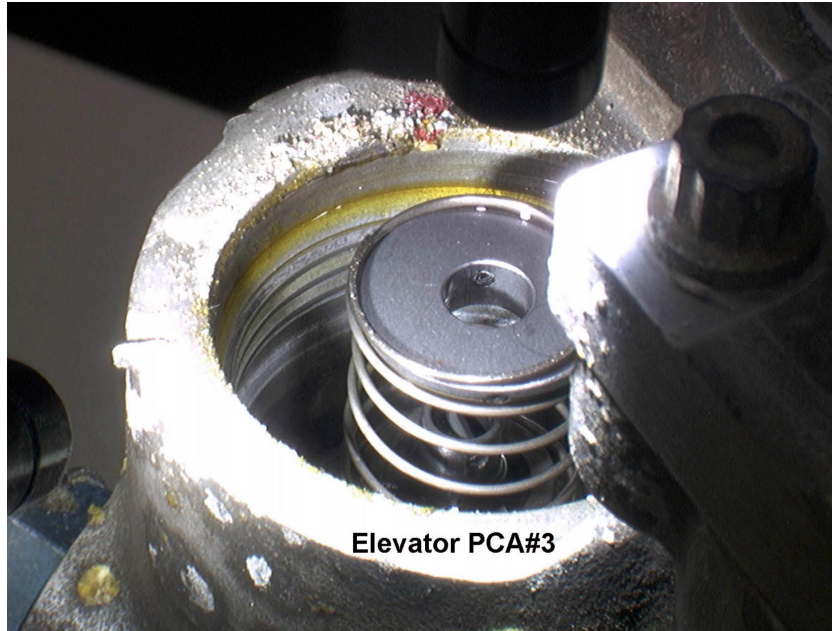
- d. Upon removal, the piston appeared straight.
- e. The rolled pin that connects the servo slide to the spring guide was sheared as if the slide moved through the spring guide.
- f. The bias spring was found rolled over the guide with one coil according to the system group chairman EQA Field Notes and two coils according to the NTSB Material Laboratory Factual Report and the CT X-ray photo.
- g. The spring guide had some markings: on the face with the smaller diameter that were caused by the slide impacting the guide several times after shearing of the pin, two markings on the outer diameter of the guide caused by the bias spring and a rub mark adjacent to the edge of the pin hole caused by the bias spring. This is according to the NTSB Material Laboratory Factual Report.

Figure 18 anomalies in PCA # 3

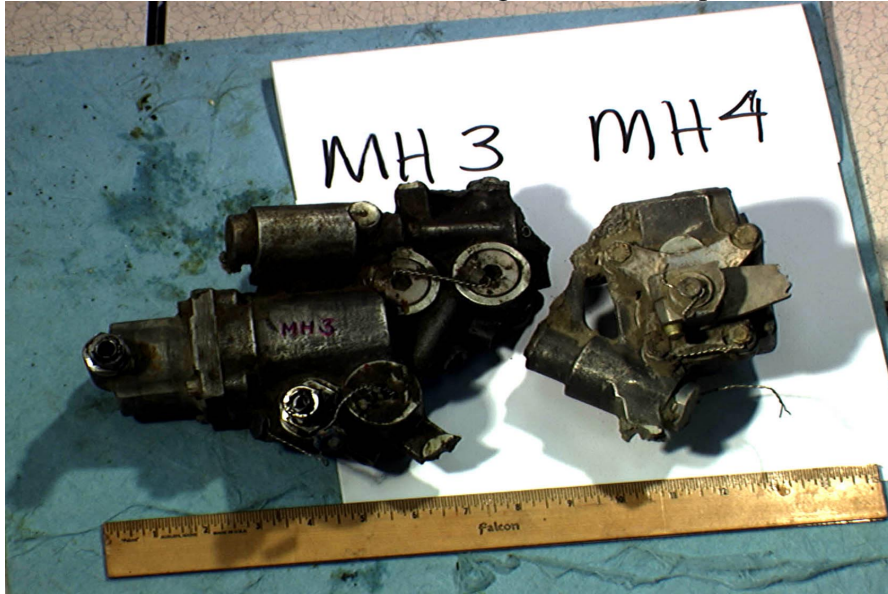
- d. A white Teflon washer was missing beneath the input crank.

Figure 19: Manifold Housing #3 and #4

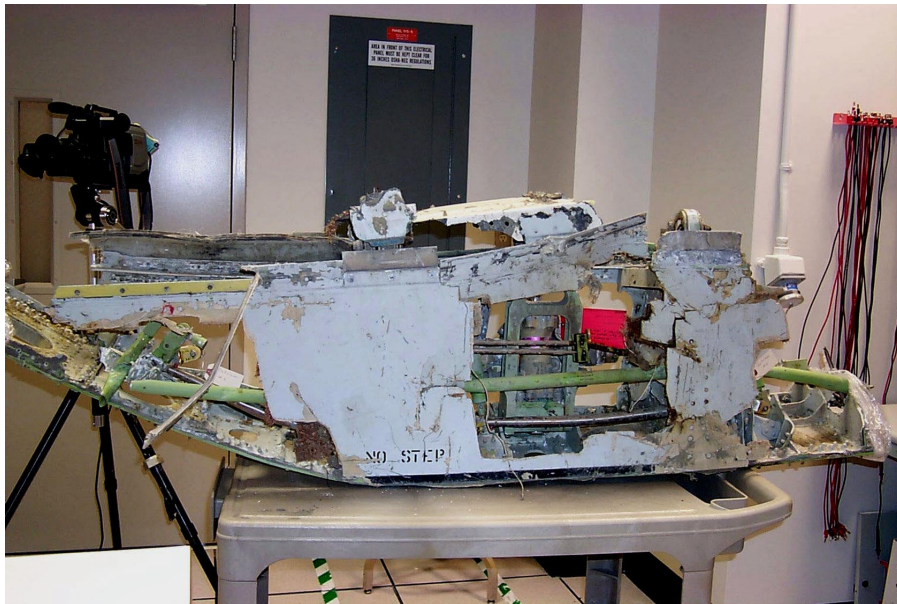
- a. This bellcrank was from the right elevator inboard position.
- b. The rivets were sheared as if the bellcrank arms were moving to a higher relative angle as mentioned in the NTSB Material Laboratory Factual Report.
- c. One of the rivets sheared flush with the recess surface while the other rivet's shear plane was in line with the bearing surface. The scanning electron microscope (SEM) examination revealed the presence of a circumferential crack in the rivet that propagated flush with the surface of the recess in the bellcrank arm.

Figure 20 Right elevator center PCA attached to stabilizer rear spar

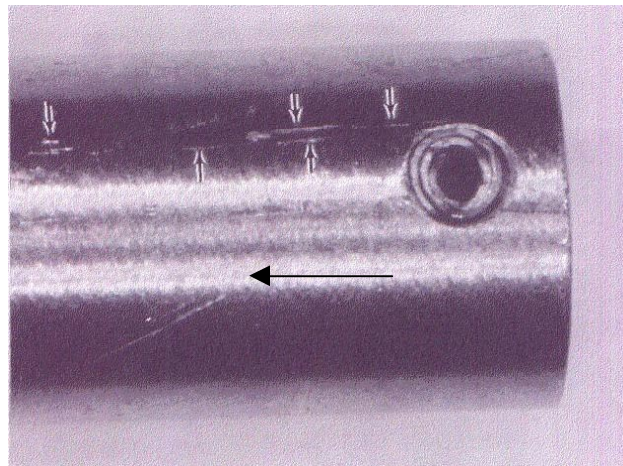
1. PCA#3 is unique among the recovered PCA's with the following findings:
 - a. The actuator was fully retracted (commanding the elevator to the trailing edge down, nose down).
 - b. Unlike PCA #1 and PCA #2, the piston rod was not bent which indicates that the PCA might have been retracted before impact.
 - c. The four bolts that attach the manifold housing to the cylinder were sheared, but the manifold was still attached to the assembly through the summing lever which revealed that it was subjected to lower impact forces than PCA#1 and PCA#2
 - d. The rolled pin that attaches the spring guide to the servo slide was sheared into three pieces. The pin shear direction is consistent with the servo slide moving through the guide hole, which is not possible unless the guide was stagnant and the slide was commanded to move in the direction through the guide.

Figure 34 PCA #3 servo slide showing the pin shear direction (Black arrow) and the score marks cause by the sheared pin.

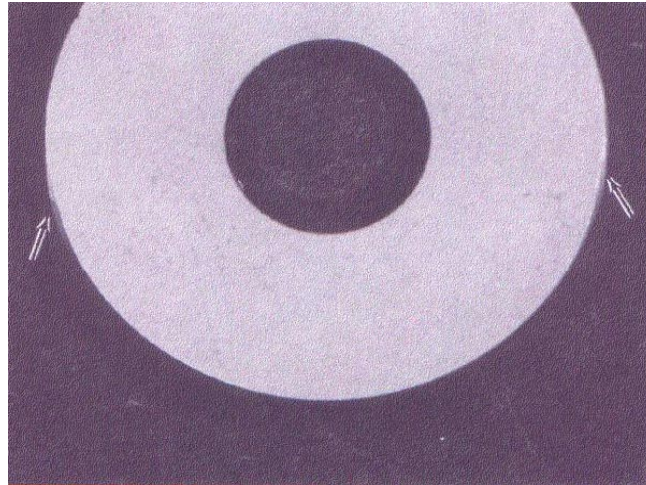
- e. The bias spring was rolled over the spring guide by two rolls, as disclosed by the X-ray image, that reduced the clearance between the spring guide and the inner surface of the servo cap and increased the jamming possibility.
- f. The spring guide has two narrow indentations on the outer diameter that appeared to be consistent with contact from the bias spring, which will not happen unless the spring was already rolled over the guide.

Figure 35 The spring guide with the two narrow indentations (The two indentations denoted by the two arrows)

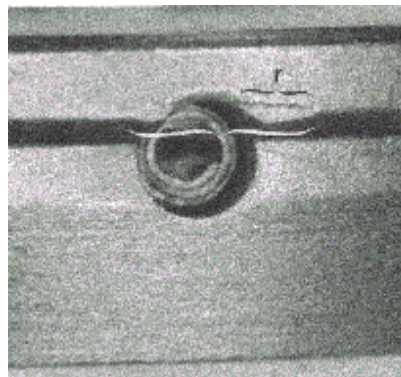
- g. One side of the guide has a rub mark adjacent to the pin hole, which might be caused by the spring trying to roll over the guide. The smaller diameter face of the guide contains a series of curved impact marks from repeated contact by the end of the servo slide, which would not happen unless the spring guide was held in position and the slide was free to impact it several times.

Figure 36 Showing the spring guide with the rub mark denoted by arrow "r".

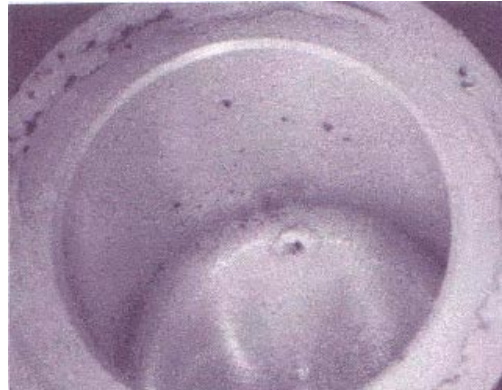
- h. The servo cap contained some particles; one of them is consistent with the chemical composition of the spring guide (might be when the spring rubbed the guide), and another consistent with the chemical composition of the servo cap, which could be due to a jamming between the spring guide and the inner surface of the servo cap.

Figure 37 The servo cap with the particles shown.

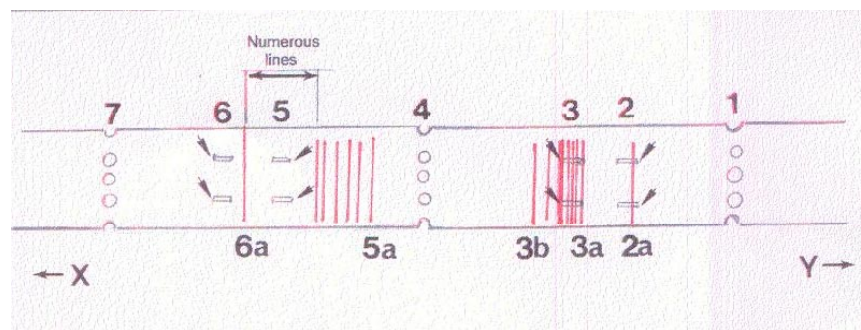
- i. The slide has several discontinuous score marks. Those marks suggest that the slide moved through the spring guide a maximum of about 0.28 inch, which will not happen unless the guide was stagnant and the slide was free to move. Also, the slide has a heavy wear mark on the input hole, which indicates that a high amount of force was exerted to move the slide in the direction of commanding the PCA to extend, the elevator to trailing edge up and nose up (trying to override a jammed slide).
- j. The servo sleeve's internal surface contains some circumferential corrosion stain bands. The position of those bands is consistent with the servo slide at a possible position off neutral (Figure 38).

Figure 38 Developed view of sleeve internal surface with the corrosion stain bands (shown in red lines). Arrows “X” and “Y” denote the spring and input end respectively. The sleeve ports denoted by numbers 1 to 7.

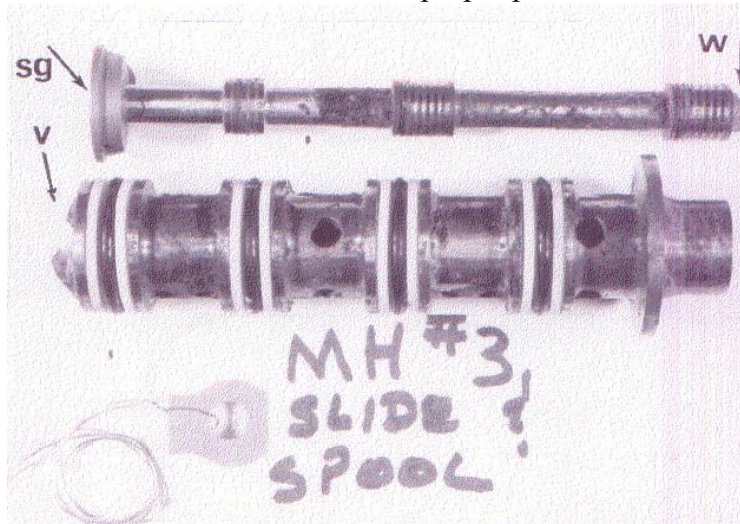
2. Inspection of MH #3 revealed that this part of a manifold was missing the input portion of the manifold (which is believed to be MH #4). Although this manifold was subjected to impact forces high enough to fracture the input portion, all the components inside were still intact and in their proper position.

Figure 39 Parts of the slide and sleeve of MH #3

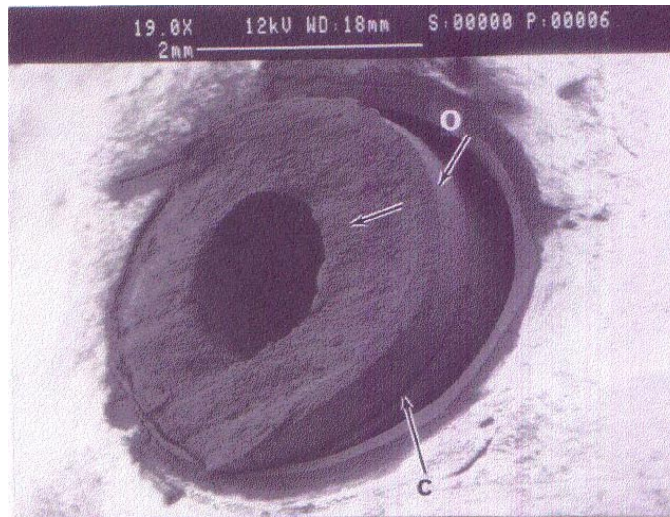
3. Examination of the recovered five bell cranks revealed that the shearing direction of the rivets in bellcrank #3 and #4 is consistent with the direction of pulling on the control column in the cockpit which might be the result of the crew trying to override a jamming condition. Also, one of the shear rivets in bellcrank #5 has a circumferential crack (denoted by the “c” arrow in Figure 40) in a different plane other than the fracture plane. That could be a potential for a bellcrank shear. The NTSB, FAA, and Boeing are studying the reason for the reported unexplained bellcrank shears that caused the FAA to issue two Airworthiness Directives AD2000-17-05 and AD2001-04-09 on August 2000 and March 2001 respectively.

Figure 40 Non-fracture plane circumferential crack, bellcrank #5.

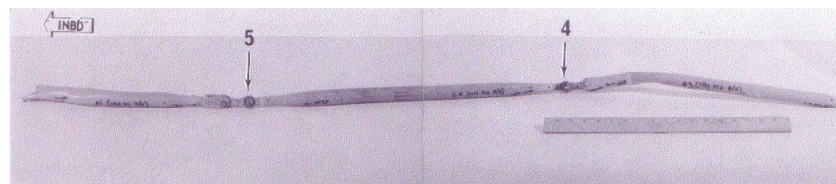
4. Examination of the input push-pull rods of the right elevator between the middle bellcrank (bellcrank #4) and inboard bellcrank (bellcrank #5) (Figure 41) revealed that this rod was subjected to the smallest amount of deformation, which is not consistent with the two bell cranks sheared in opposite directions unless one of them was sheared before impact and the other was sheared during impact. Note that this part of the push-pull rod was still connected to bellcrank #4 and bellcrank #5 when it was recovered.

Figure 41 Push-Pull rod between bellcranks #4 and #5
